# White Paper 4

## Understanding Electrical Overstress - EOS

### Industry Council on ESD Target Levels

Revision 1.2

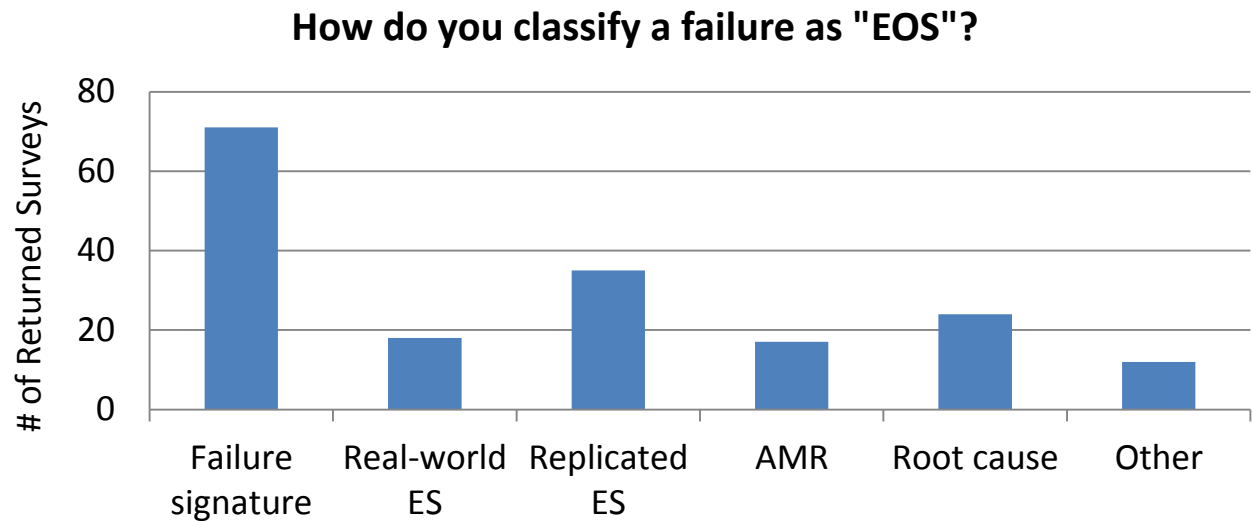
Figure 6: EOS Survey Question 2a

Figure 6 shows 71 of 81 respondents classify EOS based on a failure signature (exhibiting EOS damage), indicating obvious severe damage as a key criteria of failure. Additionally, 35 of 81 respondents determine if they can replicate the damage with an electrical stress as a criteria for classifying as EOS (note: ES in the above graph is electrical stress).

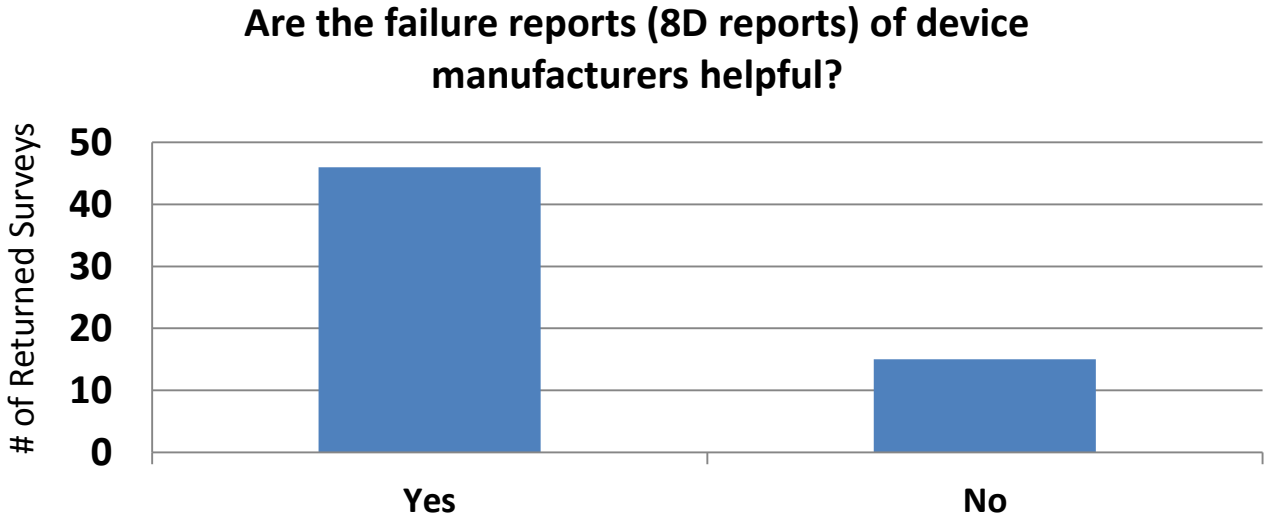
Figure 15: EOS Survey Question 6a

For those respondents familiar with the “8D” (“8 Disciplines of Problem Solving” was first attributed to Ford Motor Company in the 1980s as a new process to address and solve difficult issues) problem solving methodology of system quality issues, Figure 15 shows that 75% of respondents indicated 8D reports are helpful to them. Although this result does not tie directly to reporting of EOS related issues, it indicates the 8D methodology would be helpful for investigating issues from EOS.

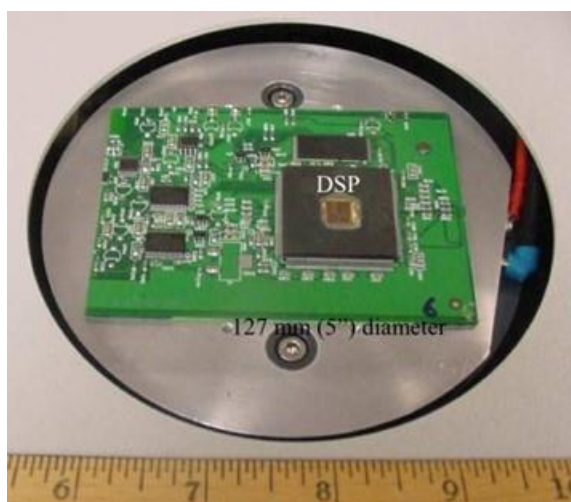
Figure 75: FICBE test method setup for the cut-down customer production board with the decapsulated DSP. The cuts were made along the top and left side of the PCB. Note that the DSP is located near the original corner of the PCB.
